NASA CR-225

OPERATION OF A HAYNES ALLOY NO. 25 FORCED CIRCULATION
LOOP TO STUDY THE EFFECTS OF HYDROGEN IN A
SIMULATED SUNFLOWER SYSTEM

By R. C. Schulze and D. B. Cooper

Prepared under Contract No. NAS 5-462 by
THOMPSON RAMO WOOLDRIDGE INC.
Cleveland, Ohio

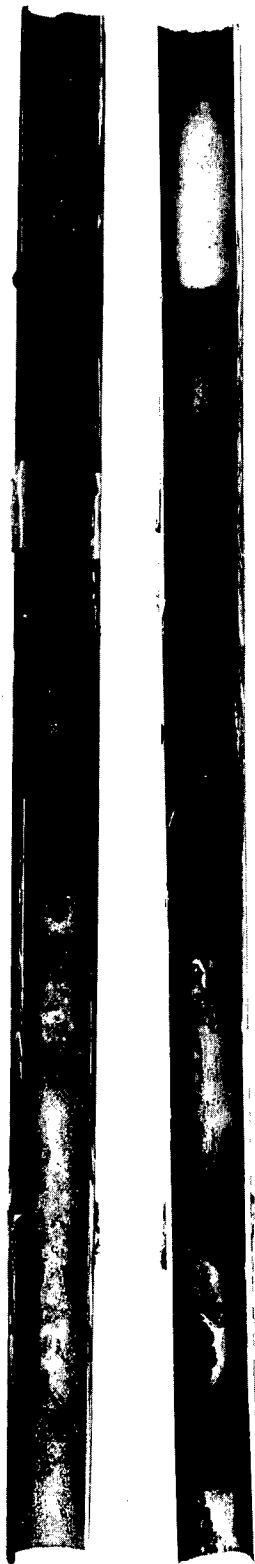
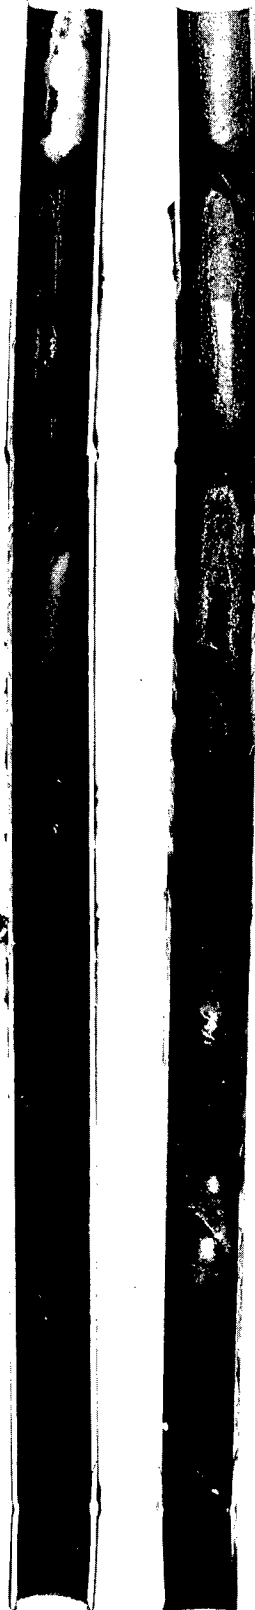
Figure 40. Macrograph of the I.D. Surfaces of the Sections Removed from the Middle Region of the Superheater (Section Nos. 22 and 23).
